New York State Department of Transportation

Yellow Flag NB23U4W025

BIN: 1065318

Location: Span 231, Stringer S2 at Pier 231.

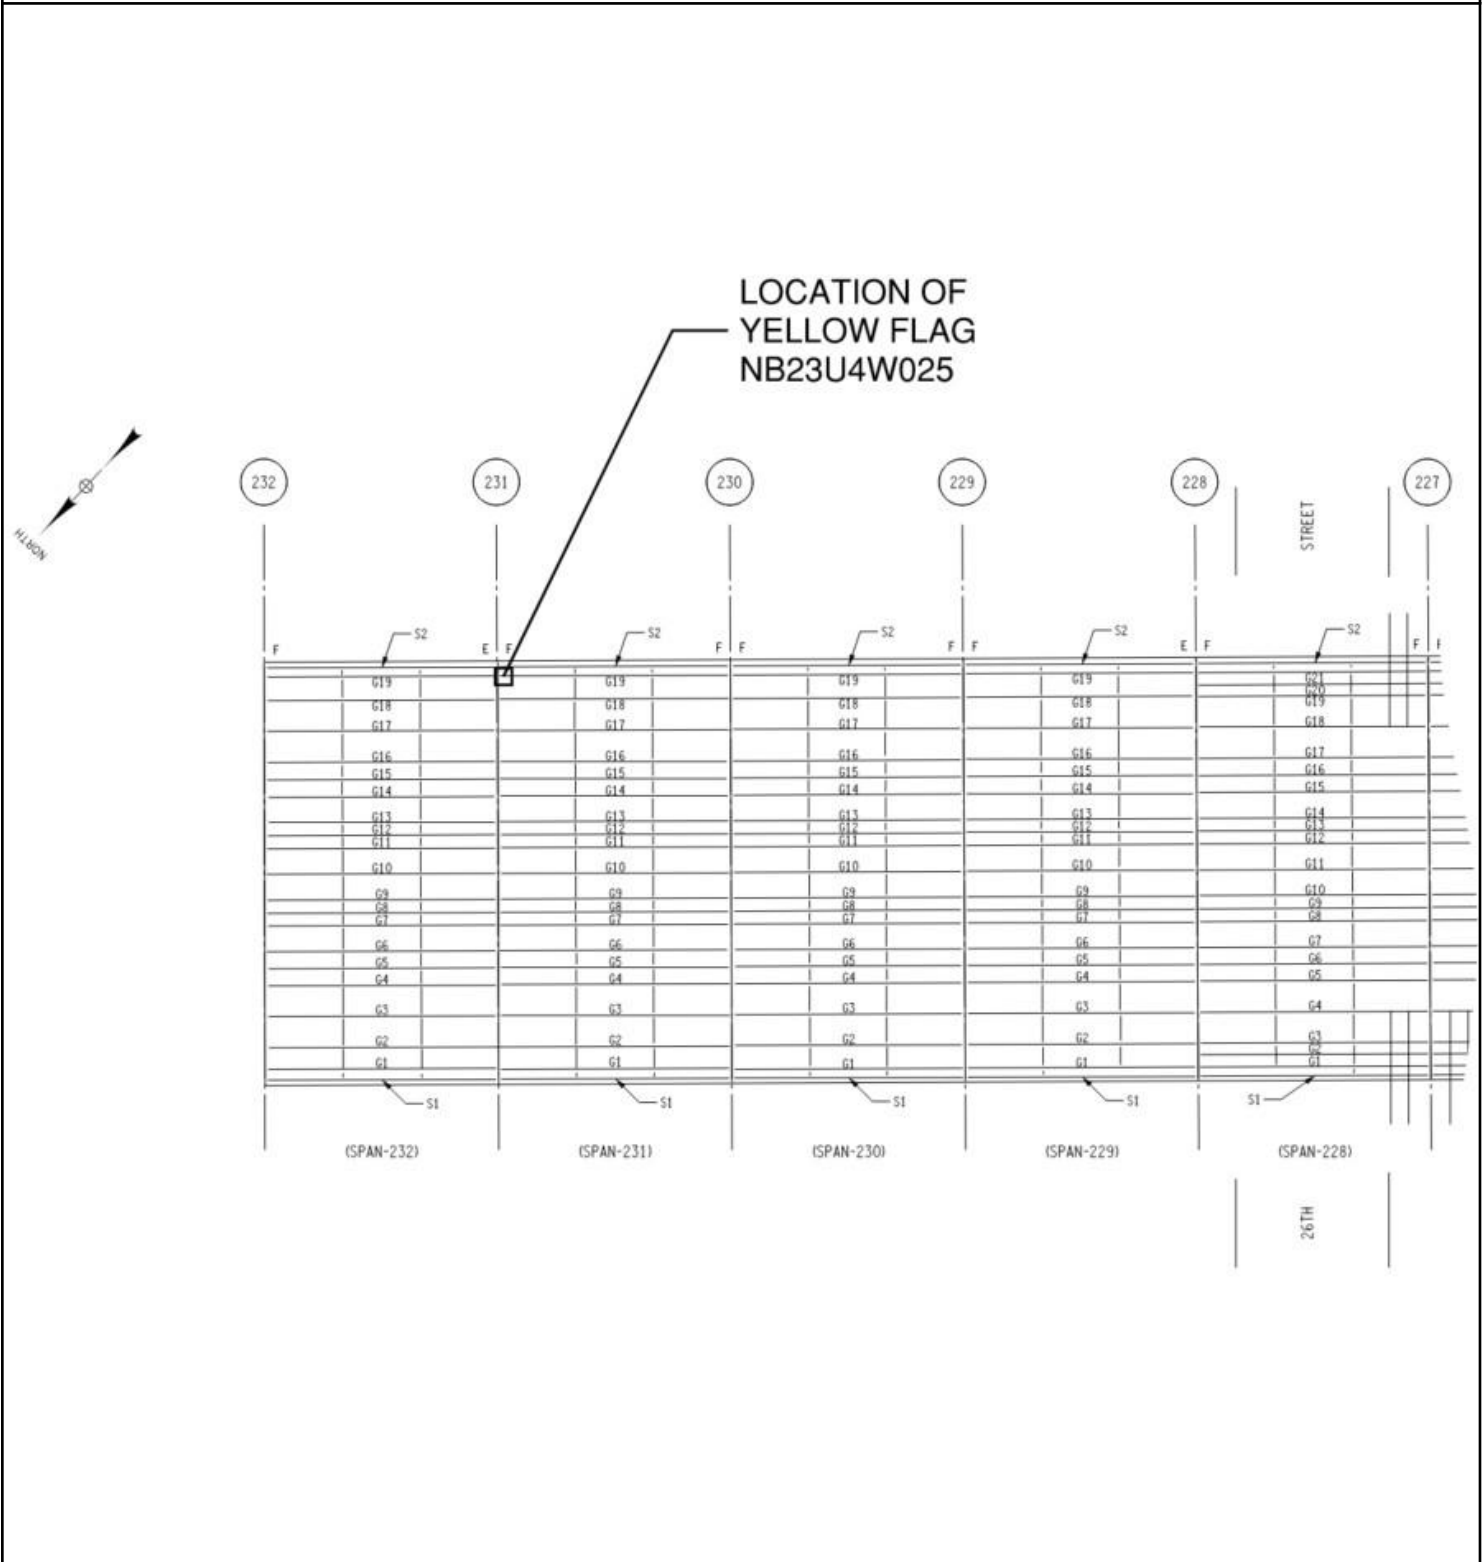
Photo Number: 1

Attachment Description: FLAG LOCATION PLAN

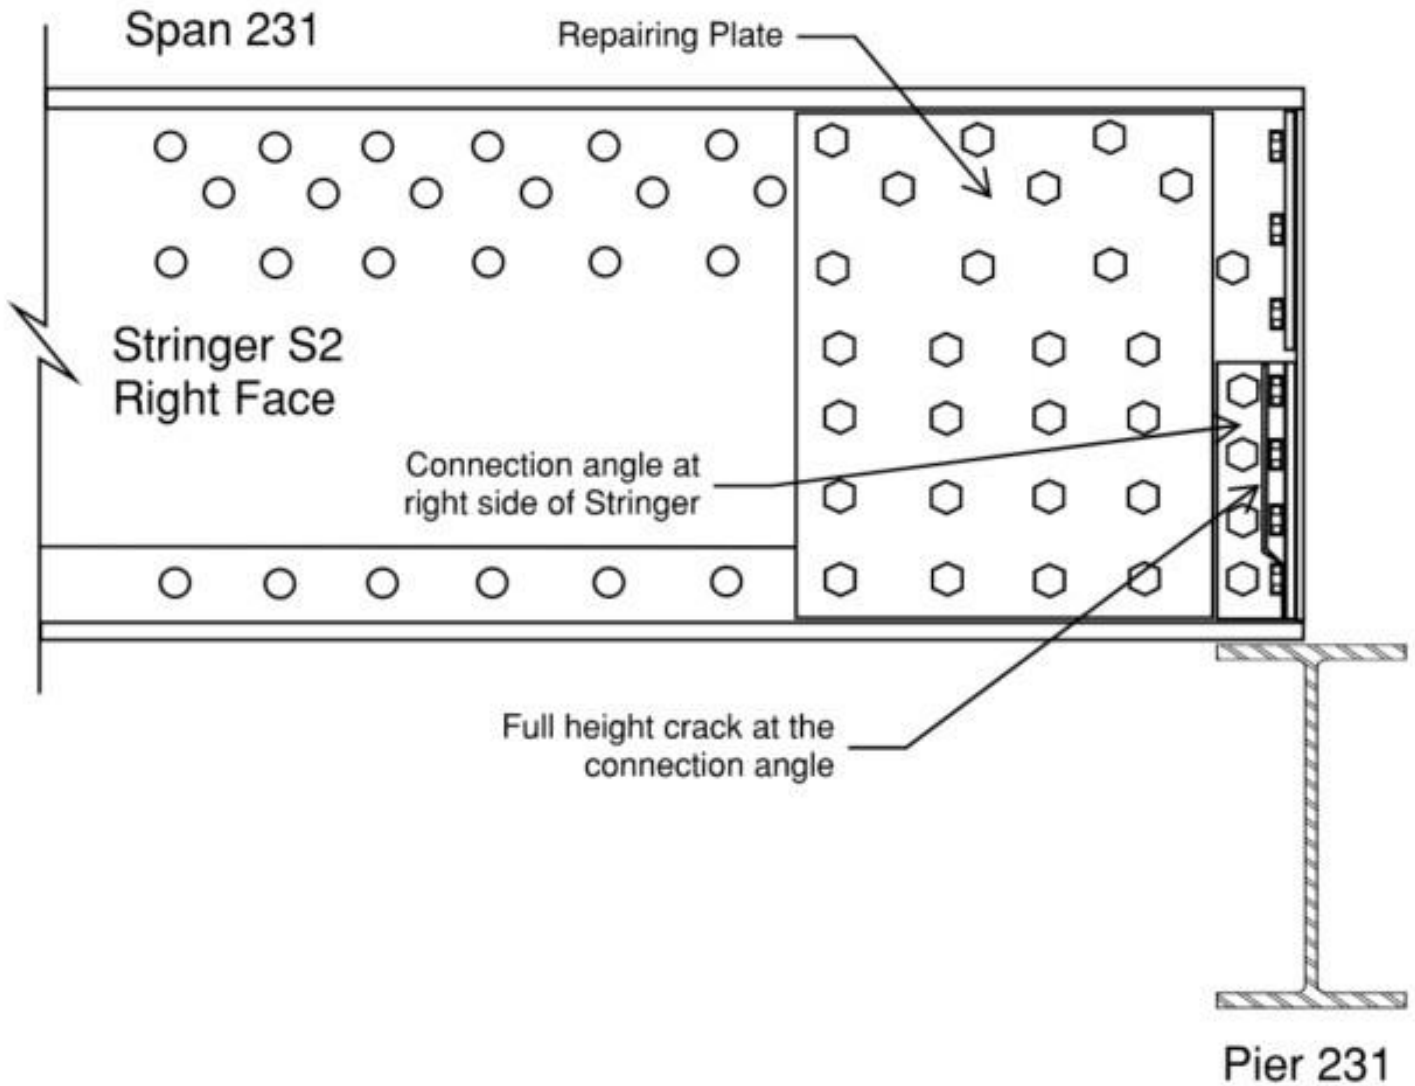
Photo Number: 2

Stringer S2 end at Pier 231 in Span 231 has a connection angle on both sides of the stringer web. The connection angle on the right side is fully cracked with cracks in the heel and outstanding leg. The connection angle on the left side exhibits a crack at the heel in the connecting leg. (See Flag Condition Sketches on Photos No. 2 and No.3 for more details).

SKETCH FOR YELLOW FLAG # NB23U4W025
SPAN 231, STRINGER S2 BEAM END AT PIER 231
(LOOKING LEFT)
N.T.S

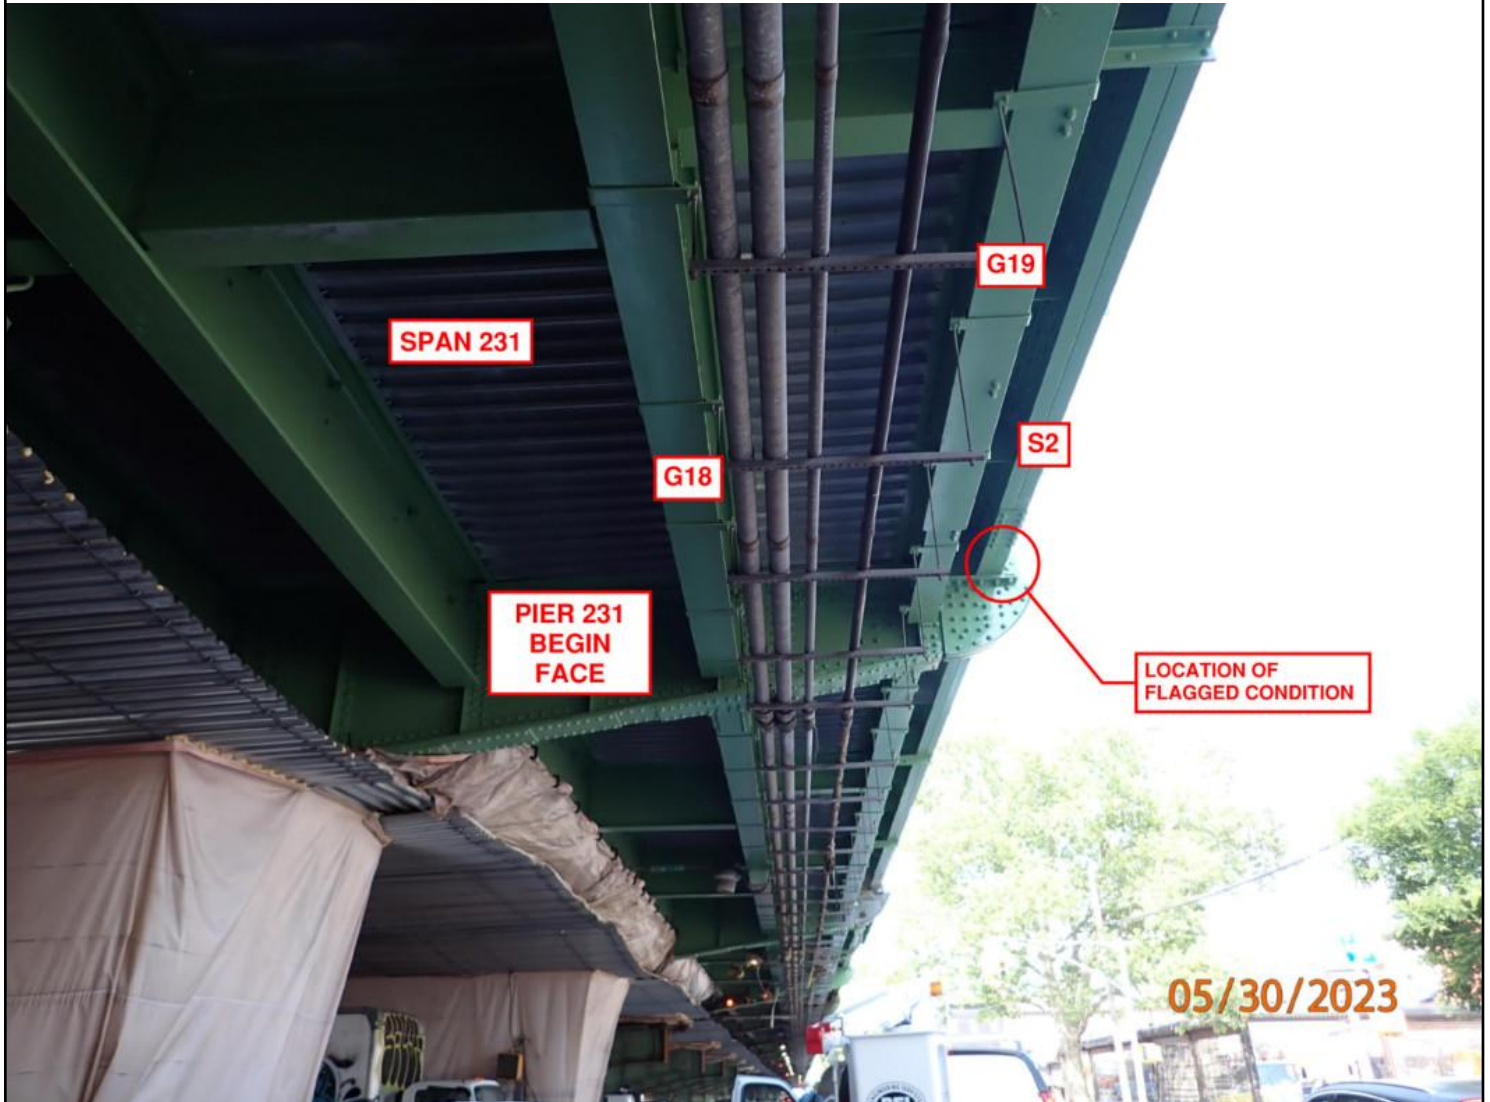
Photo Number: 4

Attachment Description: General view of flag location. Looking End - Up

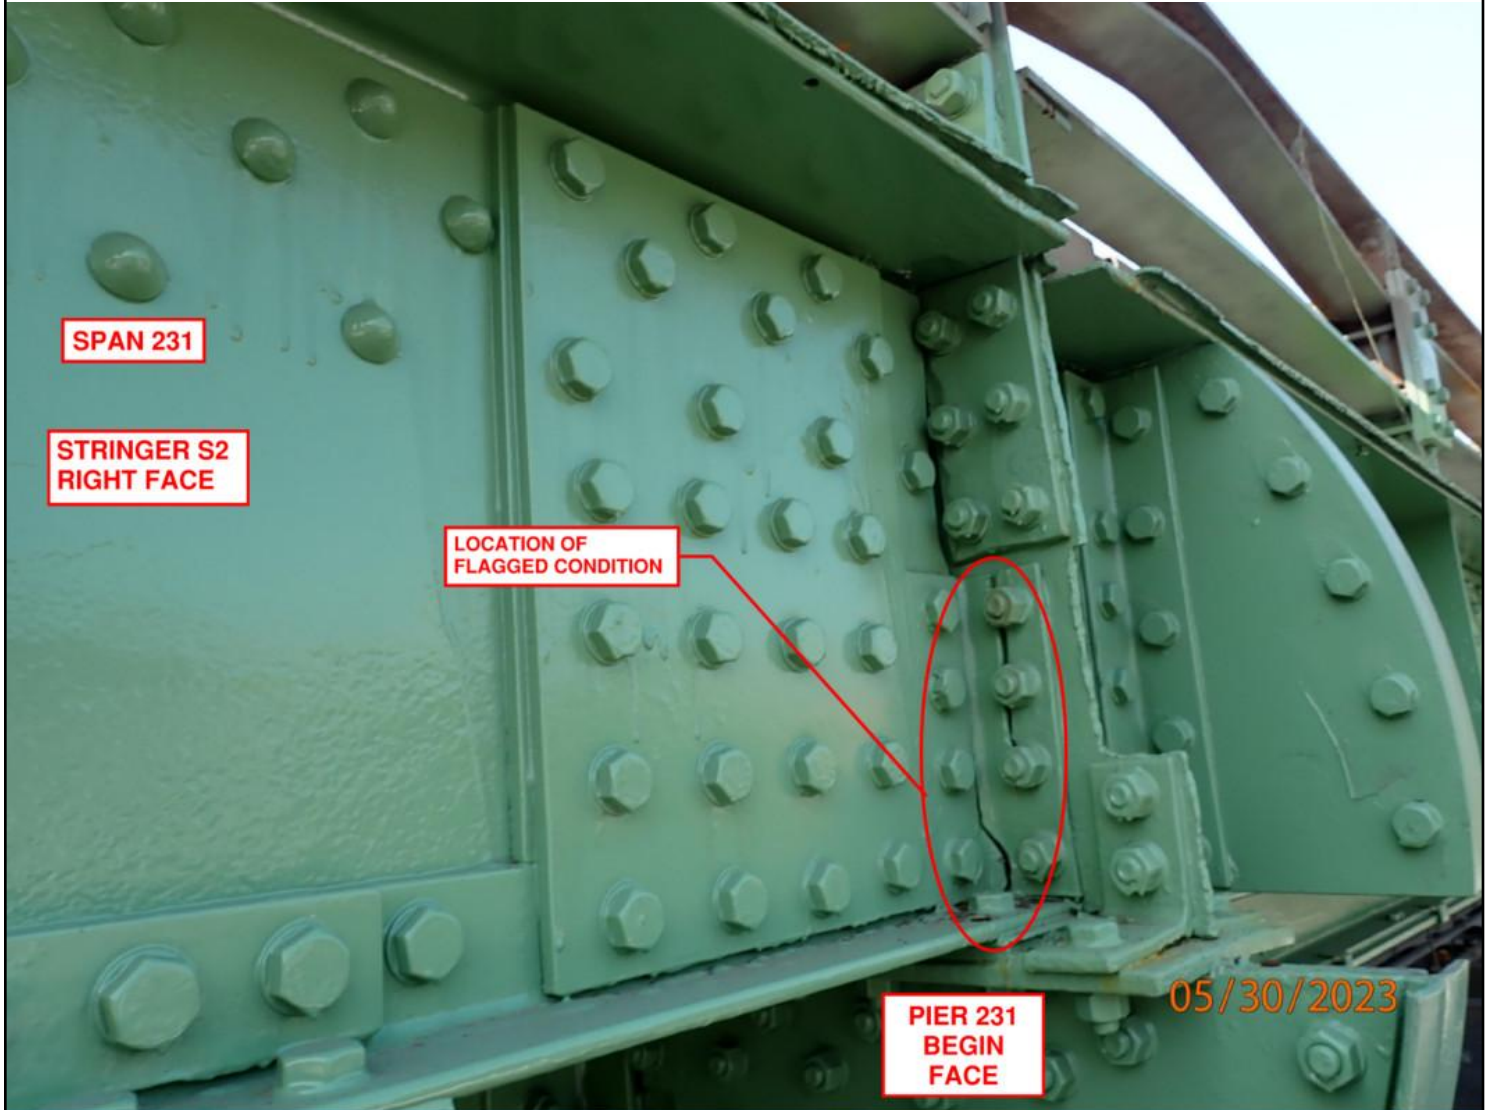
Photo Number: 5

Attachment Description: General view of flag condition on right face of Stringer S2. Looking End-Left

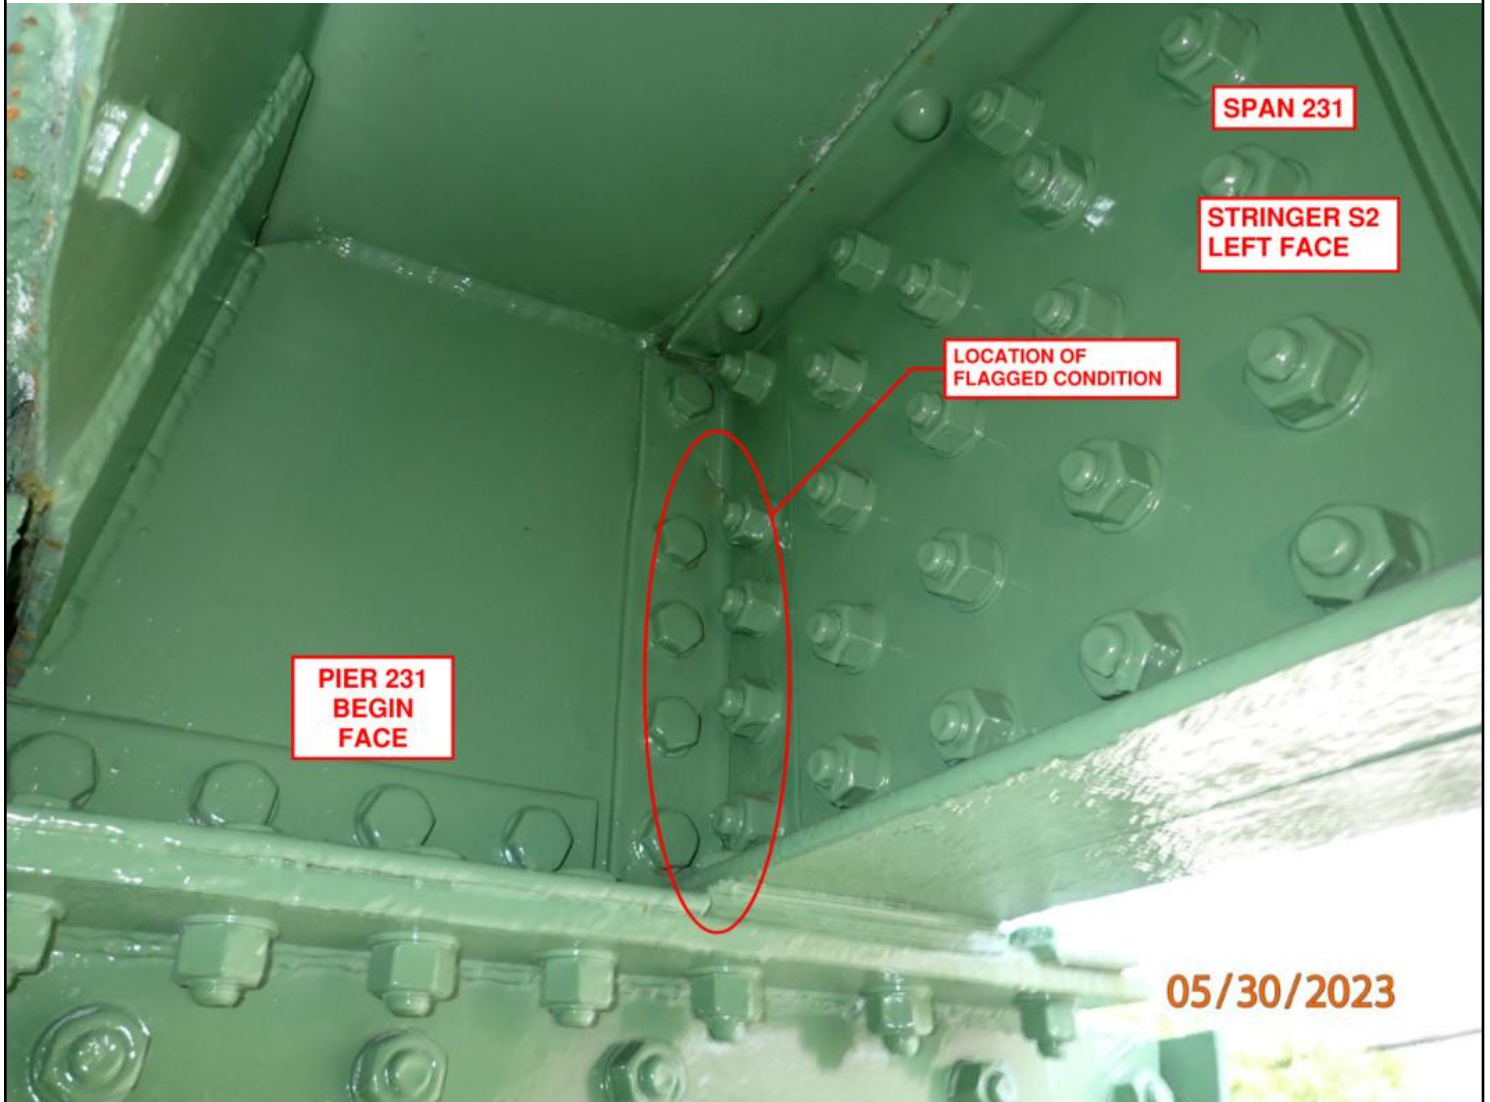
Photo Number: 6

Attachment Description: General view of flag condition on left face of Stringer S2. Looking End-Right.

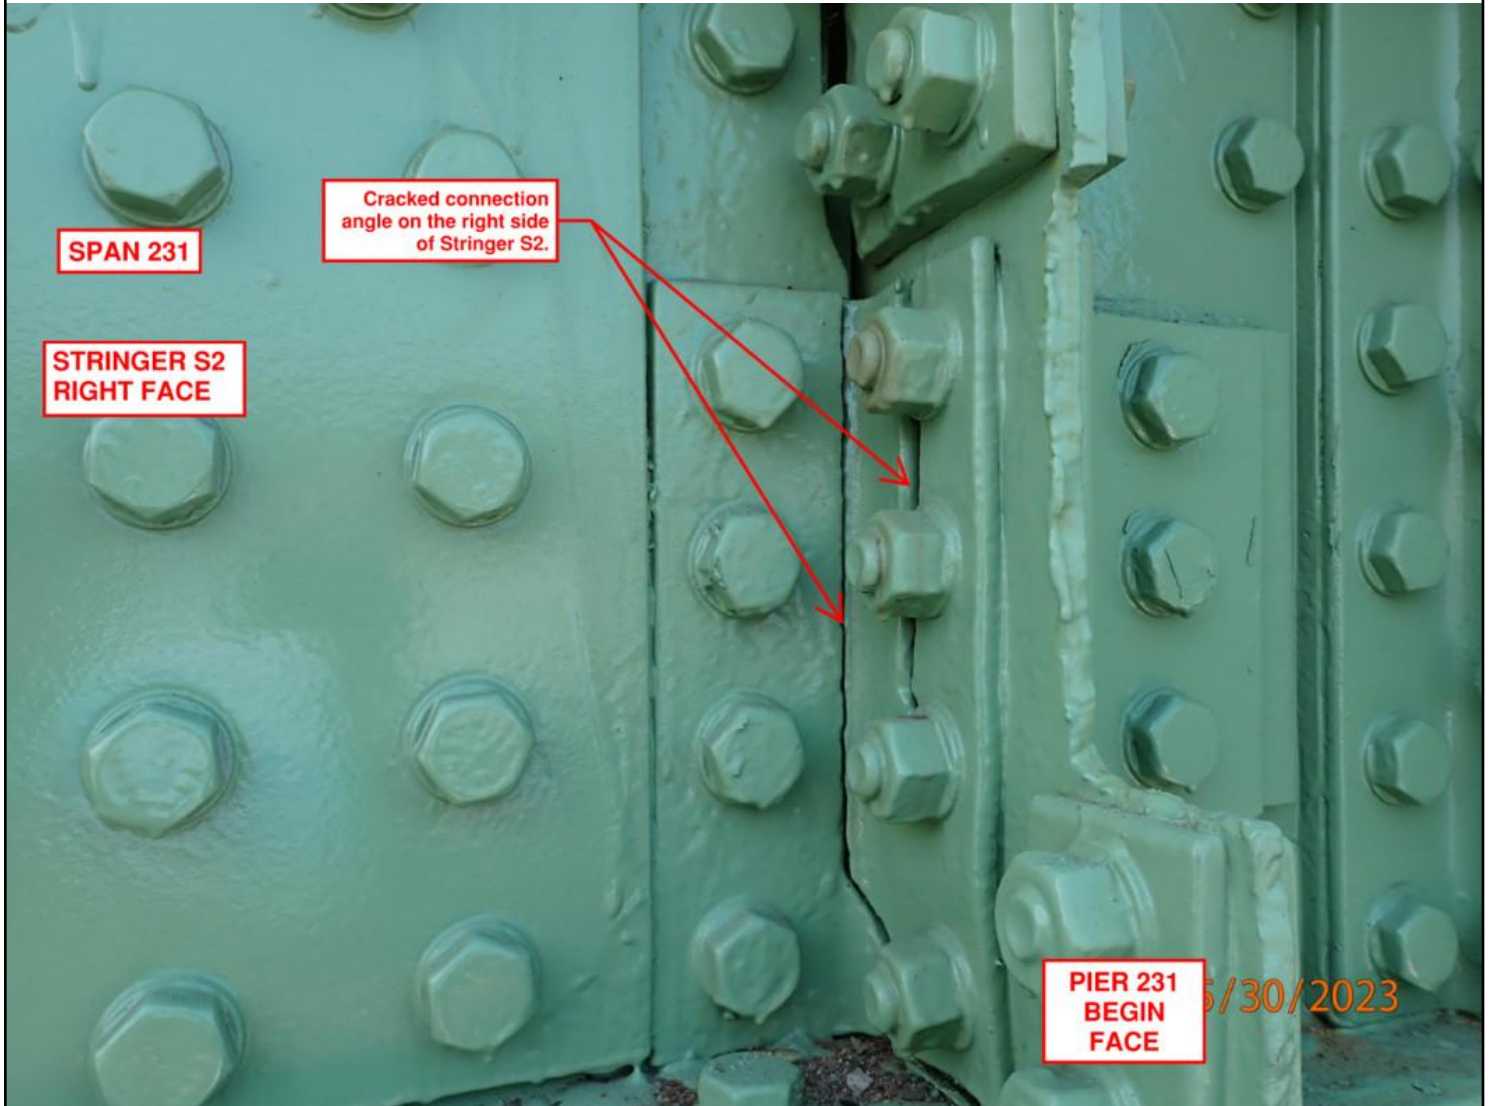
Photo Number: 7

Attachment Description: Cracked connection angle on right face of Stringer S2. Looking Left.

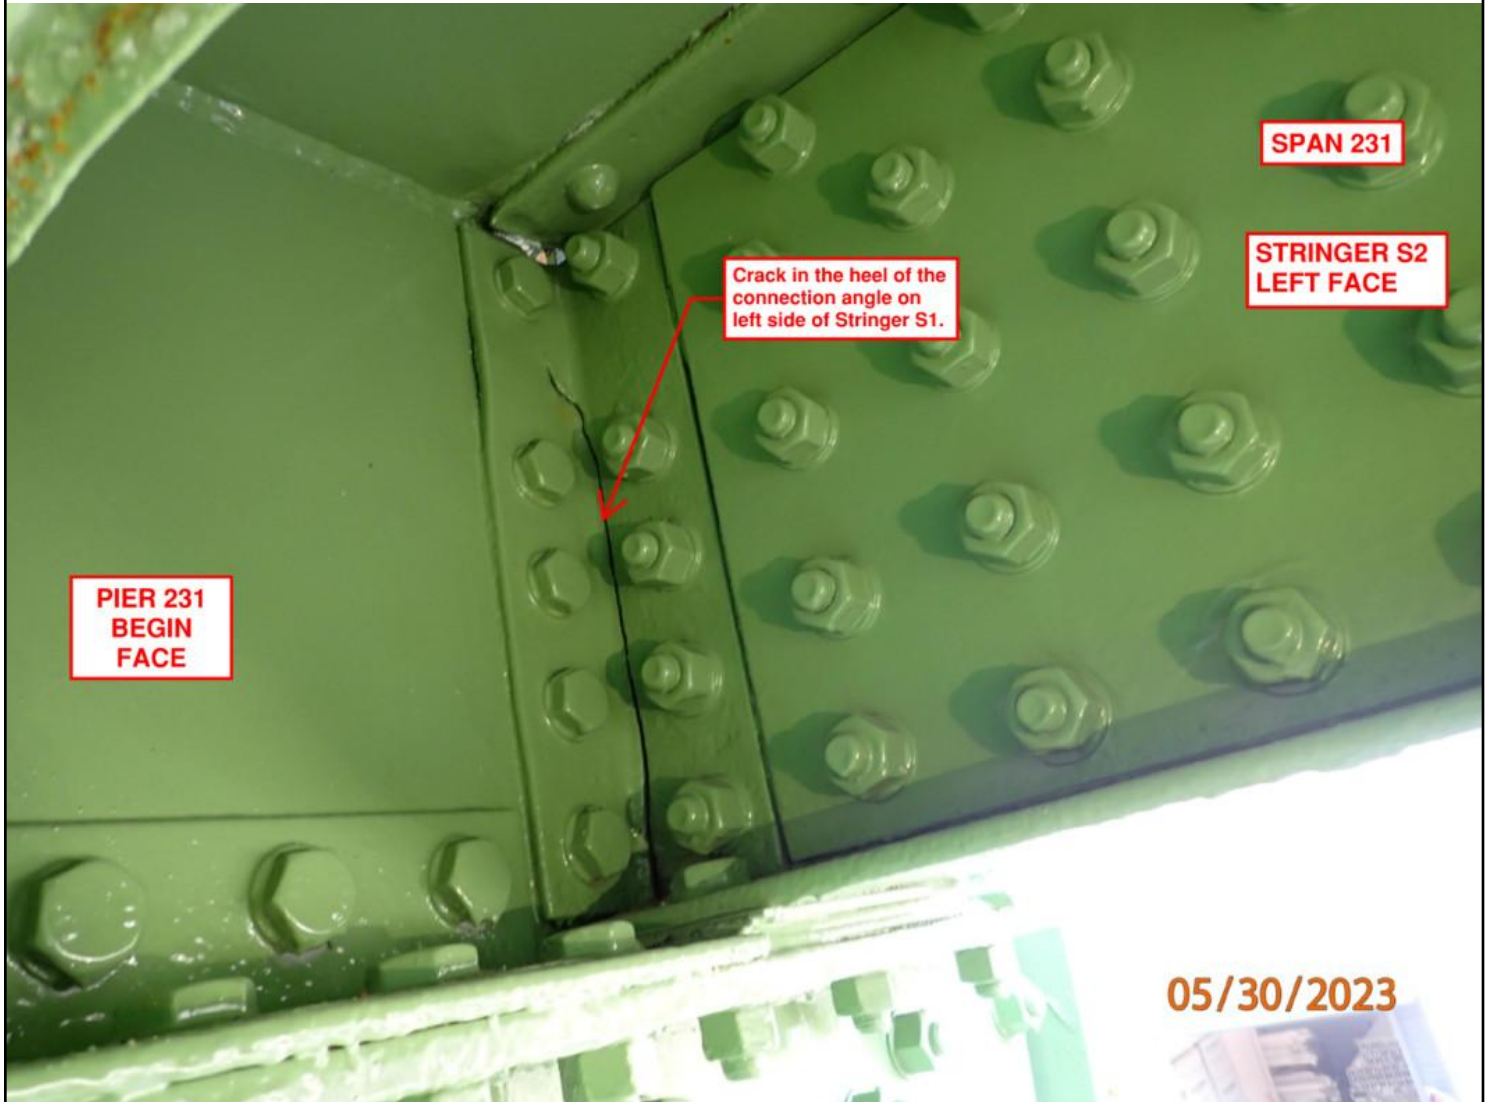
Photo Number: 8

Attachment Description: Cracked connection angle on left face of Stringer S2. Looking End - Right.
